## Solectria Renewables

Inverter Field Testing  
Engineering Report

October 10, 2014

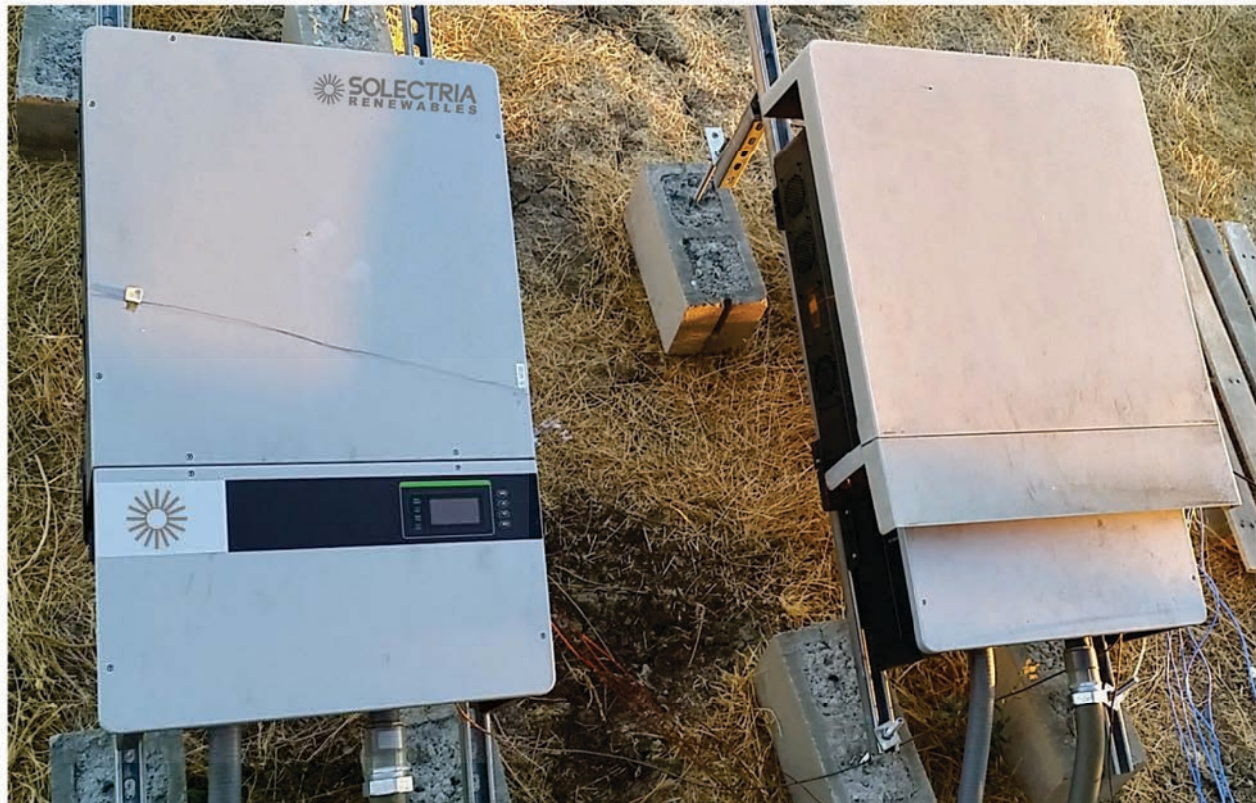
**Figure 2** Image of the installations of the two (2) Solectria PVI 28TL – the inverter on the right-hand side of the image has a shade cover installed

Figure 1 above is an image of the two (2) Solectria PVI 28TL installed at PVUSA. Inverter 1 is located on the right-hand side of the image with its shade cover installed. Inverter 2 is located on the left-hand side of the image without a shade cover. The locations of the installed thermocouples installed on the inverters to monitor case temperatures during the Test Period are shown in Figure 2 below.

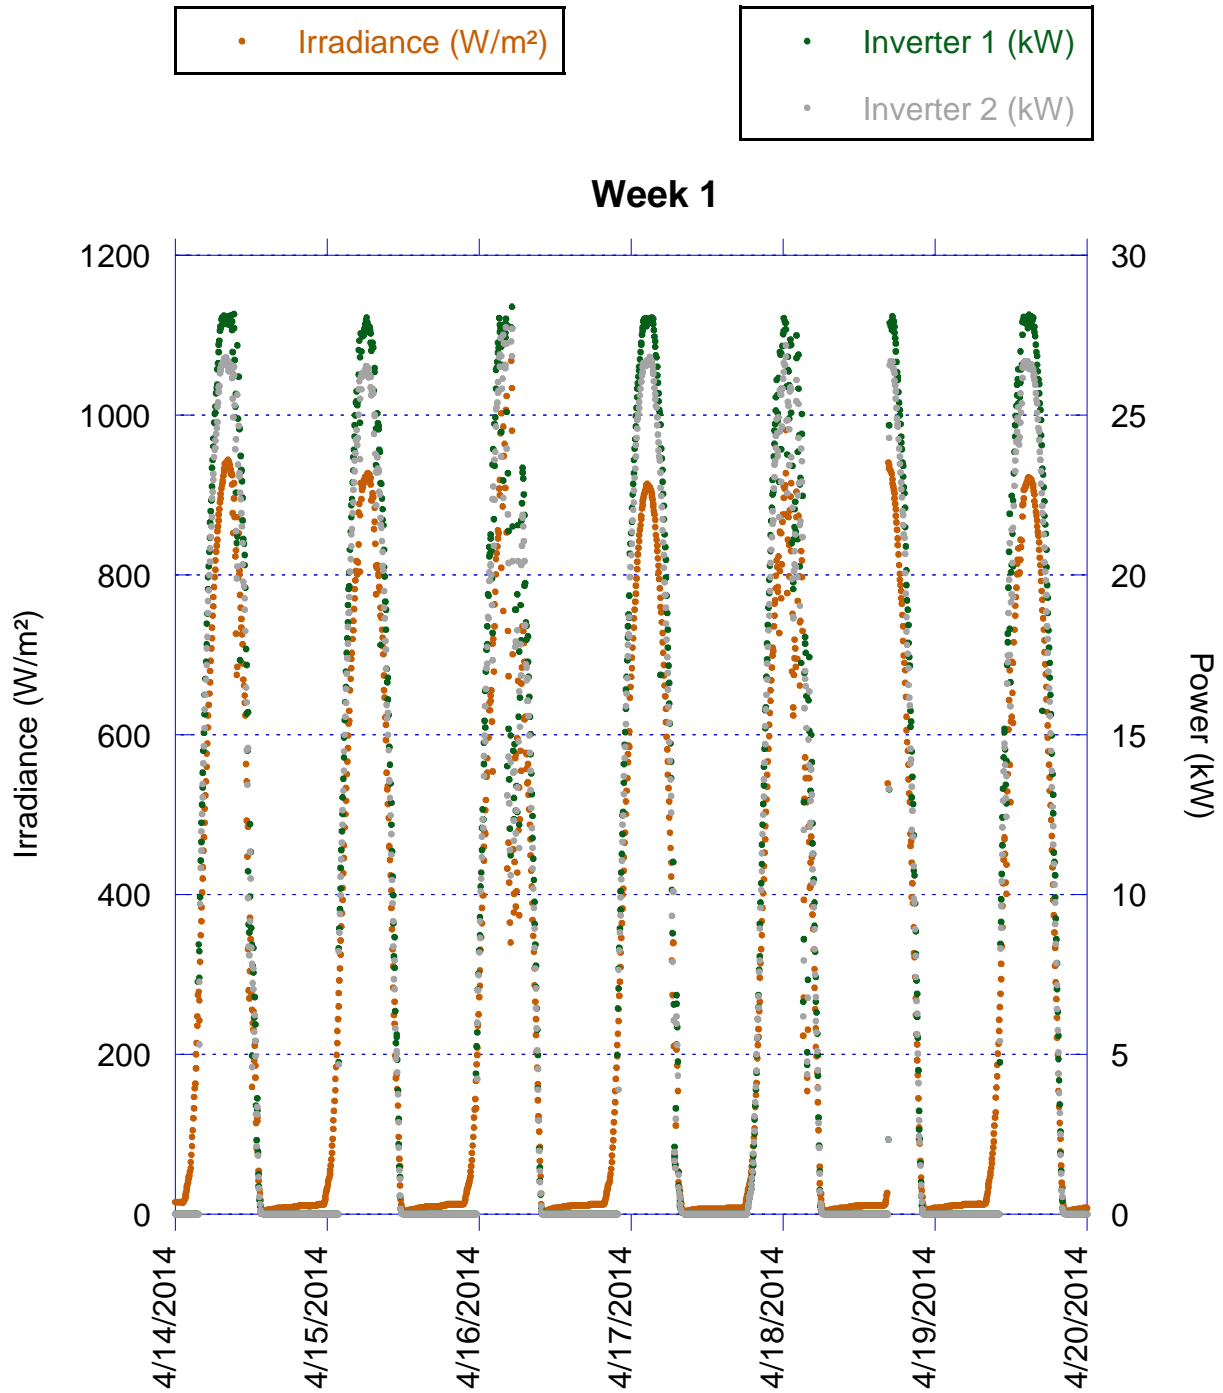
Figure 4 Plot of AC output power and irradiance for both inverters over Week 1 of the Test Period

The AC power output of each inverter versus irradiance incident on the plane-of-array (POA) is shown in the plot of Figure 3. Inverter clipping is evident in the plot at 28 kW. Figures 4 – 7 below are weekly plots of AC output power and irradiance for both inverters over the Test Period
